## Chapter Four

### The Macondo Well and the Blowout

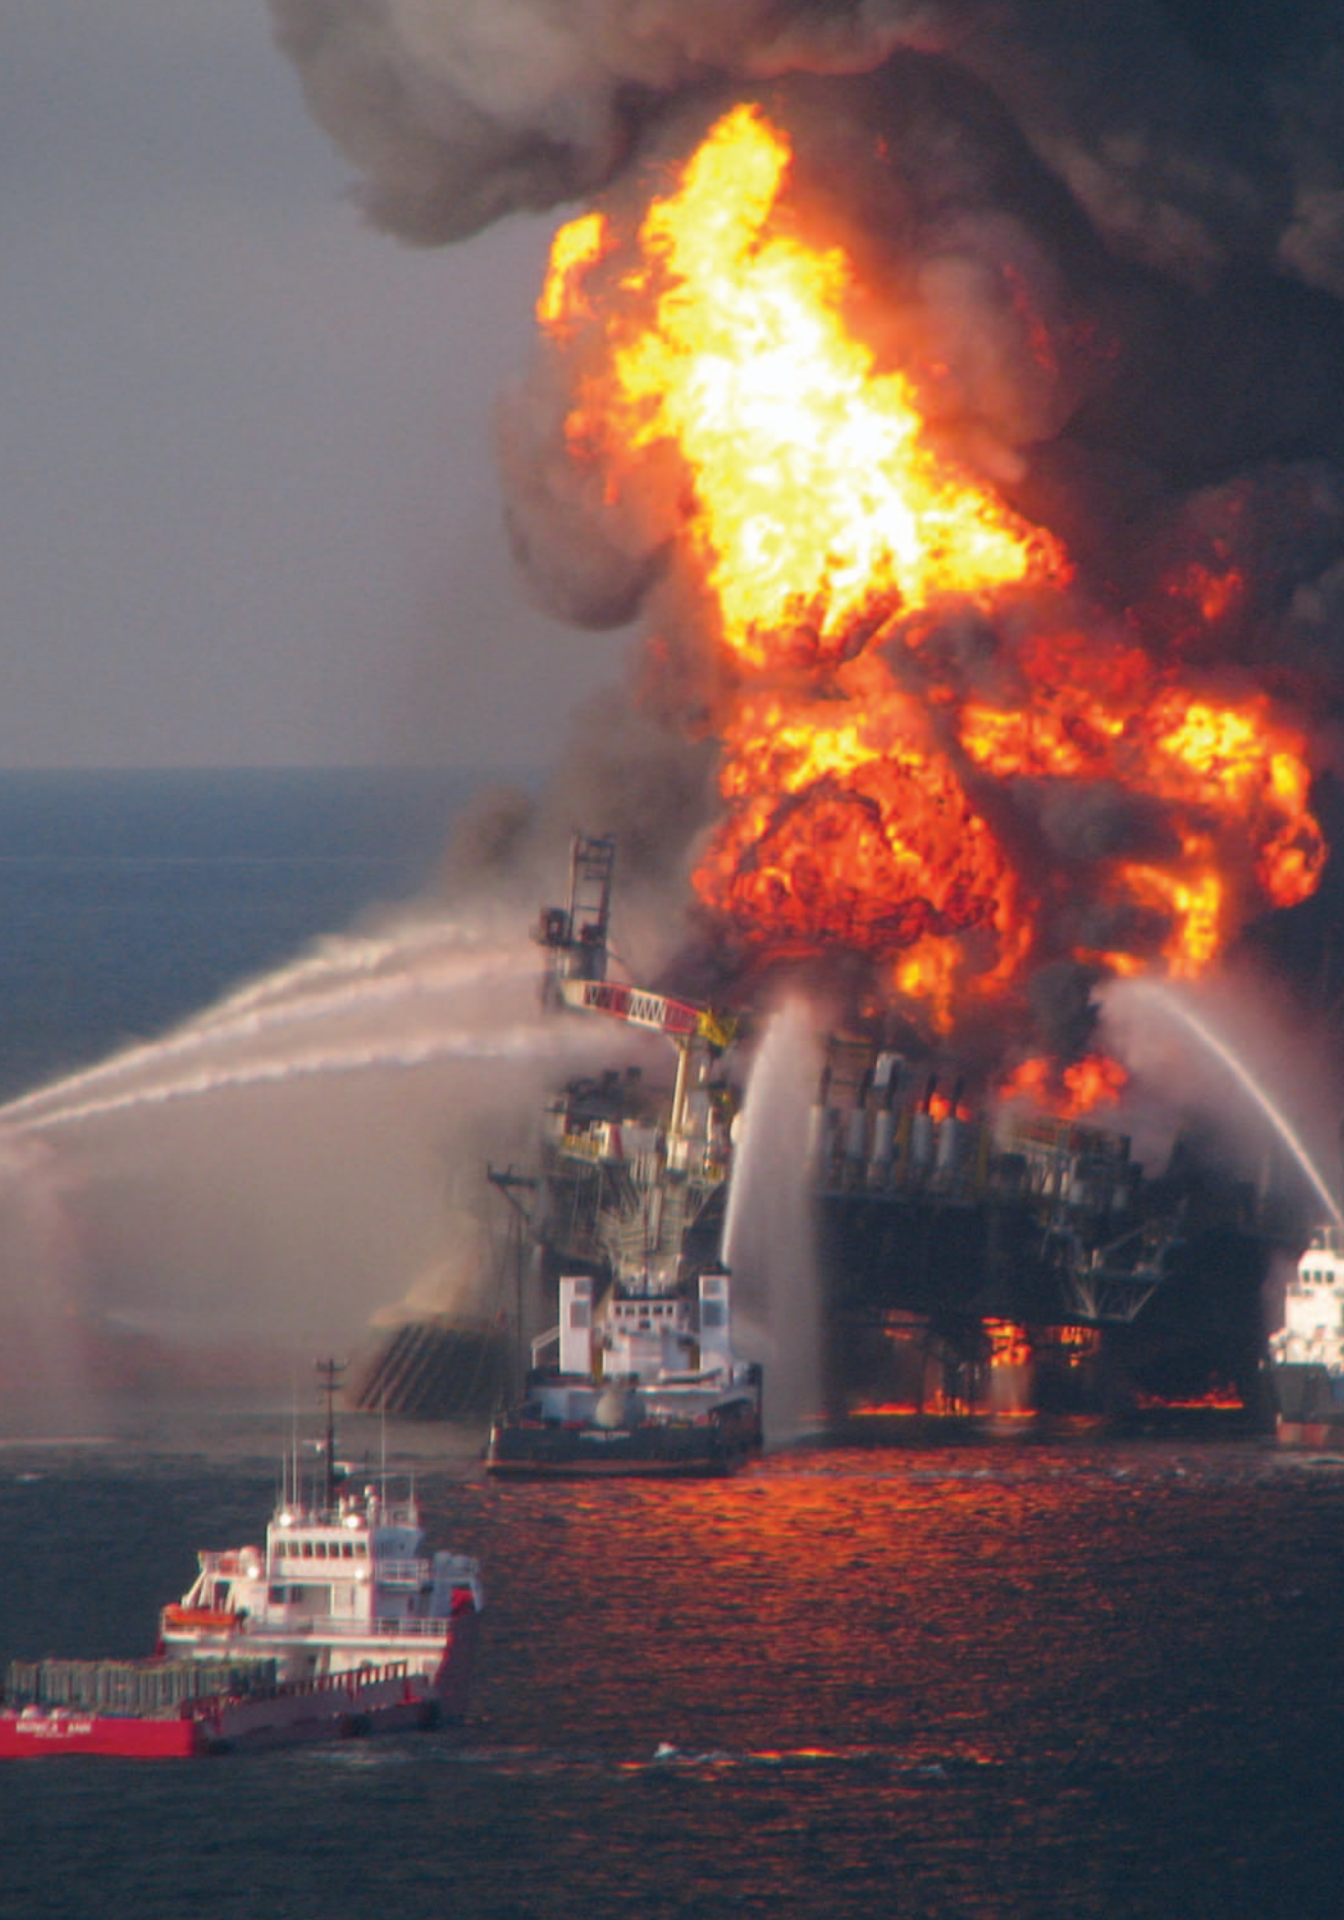
Fighting a losing battle, fireboats pour water onto the doomed rig in the hours after the Macondo well blowout. The tragic loss of the *Deepwater Horizon* at the close of the complex drilling project resulted from a series of missteps and oversights and an overall failure of management.

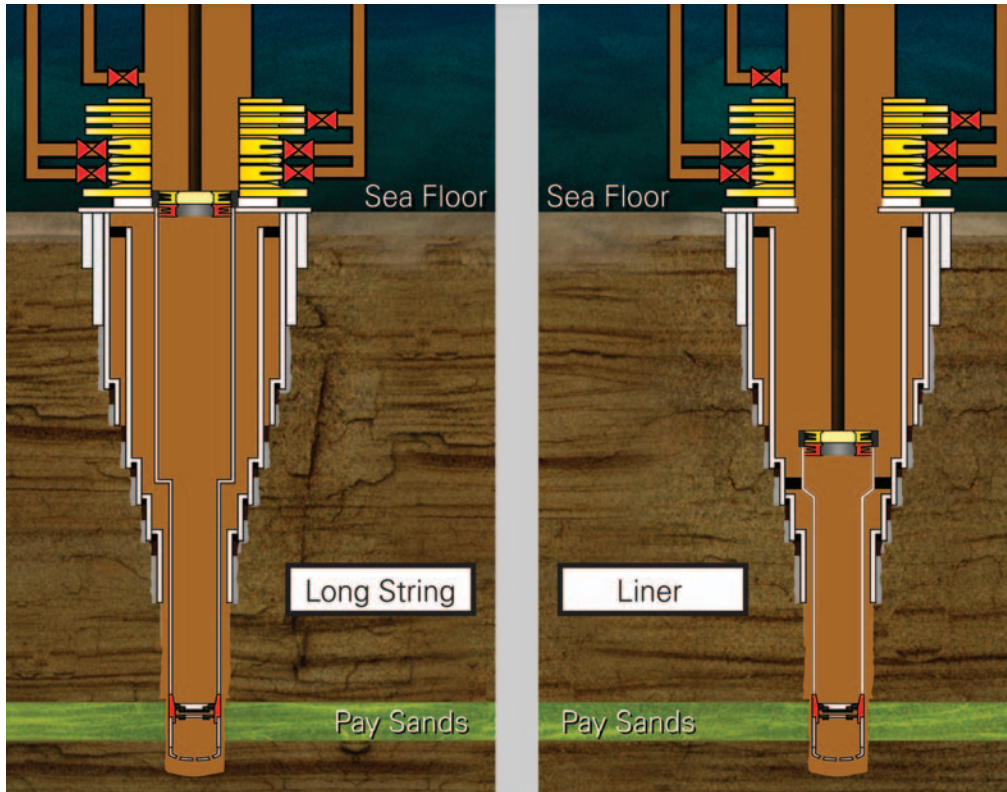
FIGURE 4.2: “Long String” vs. “Liner”

Two options for the Macondo production casing.

**Long string casing vs. liner.** BP's decision to employ a long string was not unprecedented. Long strings are used with some frequency by other operators in the Gulf of Mexico, although not very often at wells like Macondo—a deepwater well in an unfamiliar geology requiring a finesse cement job.<sup>126</sup> It is not clear whether the decision to use a long string well design contributed directly to the blowout:<sup>127</sup> But it did increase the difficulty of obtaining a reliable primary cement job in several respects,<sup>128</sup> and primary cement failure was a direct cause of the blowout. The long string decision should have led BP and Halliburton to be on heightened alert for any signs of primary cement failure.

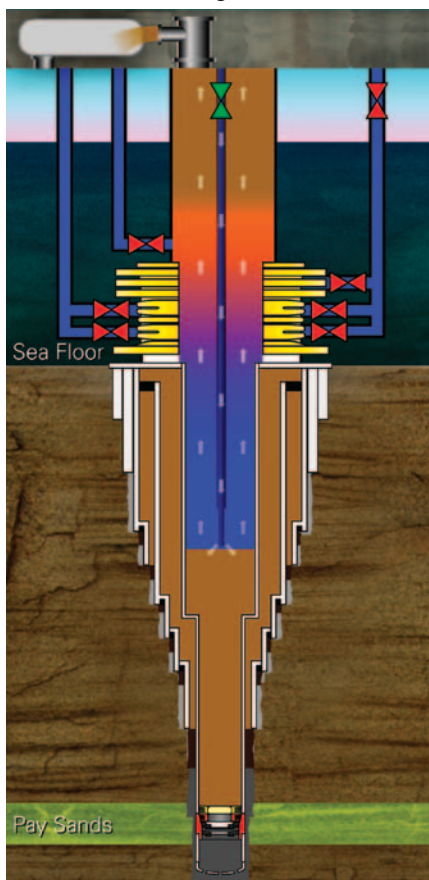
**FIGURE 4.6: Displacing Mud With Spacer and Seawater Before the Negative Pressure Test**

Seawater (blue) displaces mud (brown) from wellbore and riser, with spacer fluid separating the two.

While drilling crews routinely use water-based spacer fluids to separate oil-based drilling mud from seawater, the spacer BP chose to use during the negative pressure test was unusual. BP had directed M-I SWACO mud engineers on the rig to create a spacer out of two different lost-circulation materials left over on the rig—the heavy, viscous drilling fluids used to patch fractures in the formation when the crew experiences lost returns.<sup>71</sup> M-I SWACO had previously mixed two different unused batches, or “pills,” of lost-circulation materials in case there were further lost returns.<sup>72</sup> BP wanted to use these materials as spacer in order to avoid having to dispose of them onshore as hazardous waste pursuant to the Resource and Conservation Recovery Act, exploiting an exception that allows companies to dump water-based “drilling fluids” overboard if they have been circulated down through a well.<sup>73</sup> At BP’s direction, M-I SWACO combined the materials to create an unusually large volume of spacer that had never previously been used by anyone on the rig or by BP as a spacer, nor been thoroughly tested for that purpose.<sup>74</sup>

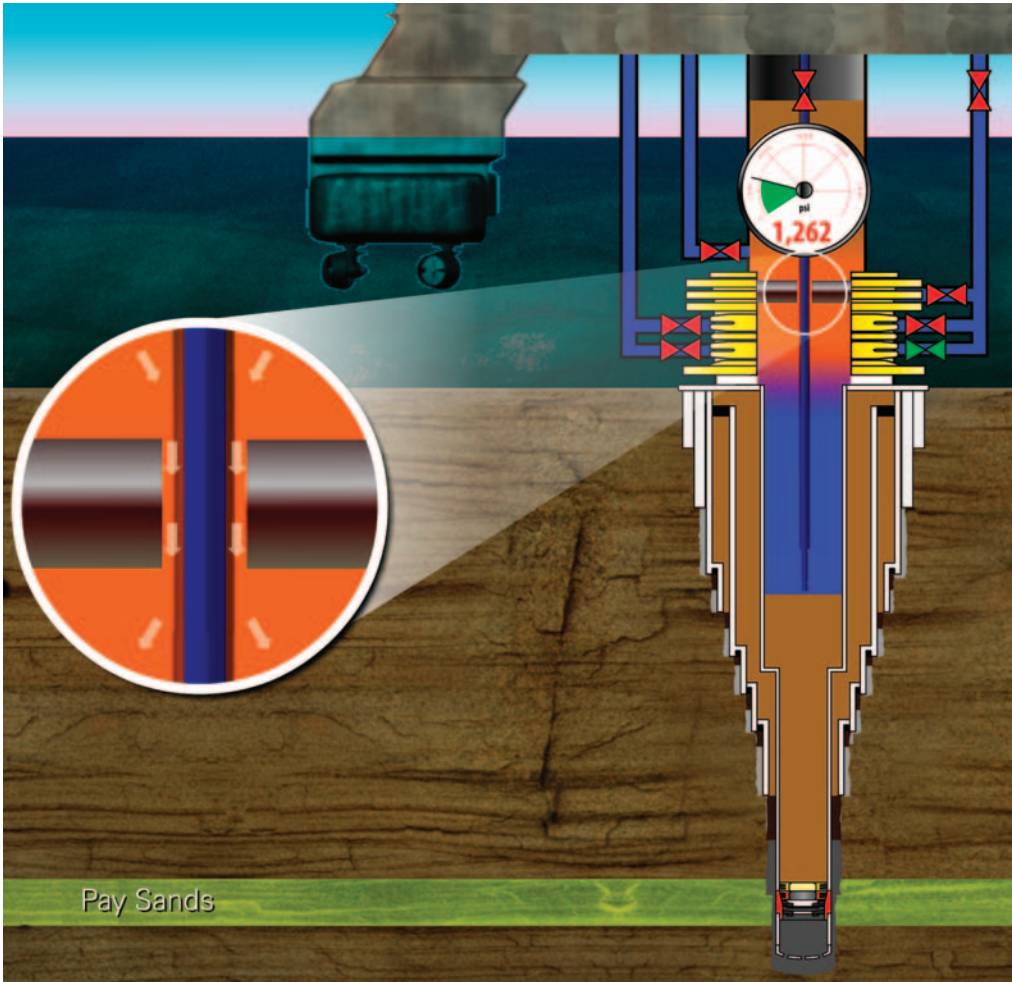
FIGURE 4.7: Fluids Leak Past Annular Preventer

The crew had noticed that the fluid level inside the riser was dropping, suggesting that spacer was leaking down past the annular preventer, out of the riser, and into the well (Figure 4.7). Harrell, who stayed behind in the drill shack as the tour continued, ordered the annular preventer closed more tightly to stop the leak.<sup>77</sup> Harrell then left the rig floor.

Spacer fluids (orange) leak past annular preventer.

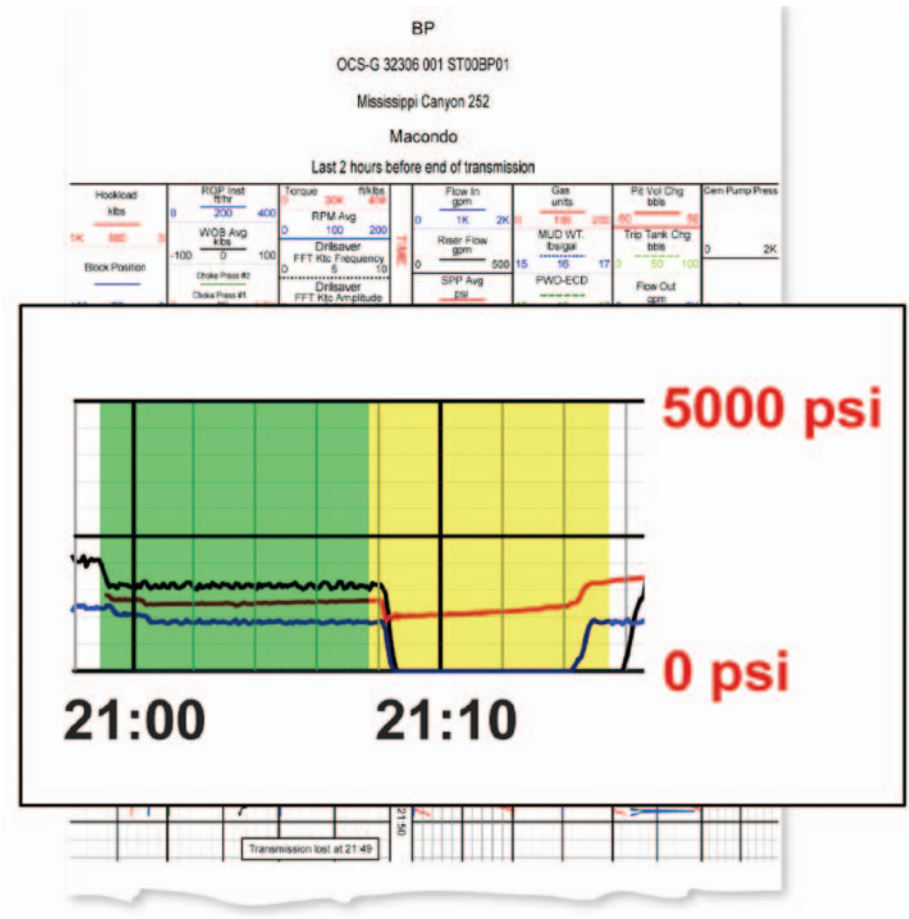
FIGURE 4.8: Increasing Drill-Pipe Pressure

Sperry Sun drill-pipe pressure data (in red).

magnitude of the increase may have appeared only as a subtle trend on the Sperry Sun display, the change in direction from decreasing to increasing was not.<sup>91</sup>

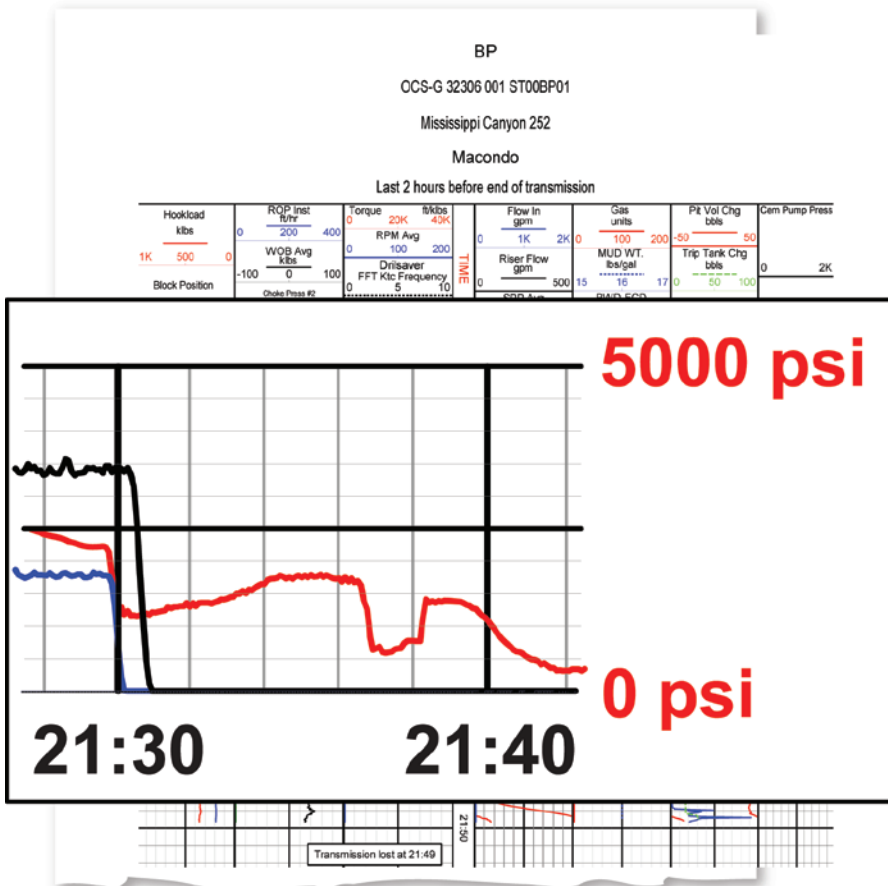
FIGURE 4.9: Fluctuating Drill-Pipe Pressure

Sperry Sun drill-pipe pressure data (in red).

floorhand Caleb Holloway to bleed off the drill-pipe pressure, in an apparent attempt to eliminate the difference.<sup>112</sup> The drill-pipe pressure initially dropped off as expected, but immediately began climbing again.<sup>113</sup> Young and Anderson left the rig floor.<sup>114</sup> Despite the mounting evidence of a kick, however, neither Revette nor Anderson performed a visual flow check or shut in the well.
